② National Dam Inspection Program, Auburn Dam

AUBURN DAM, SCHUYLKILL COUNTY,
PENNSYLVANIA

(NDS I.D. NO. PA 00670)
(DER I.D. NO. 54-163)

PHASE I INSPECTION REPORT,
NATIONAL DAM INSPECTION PROGRAM

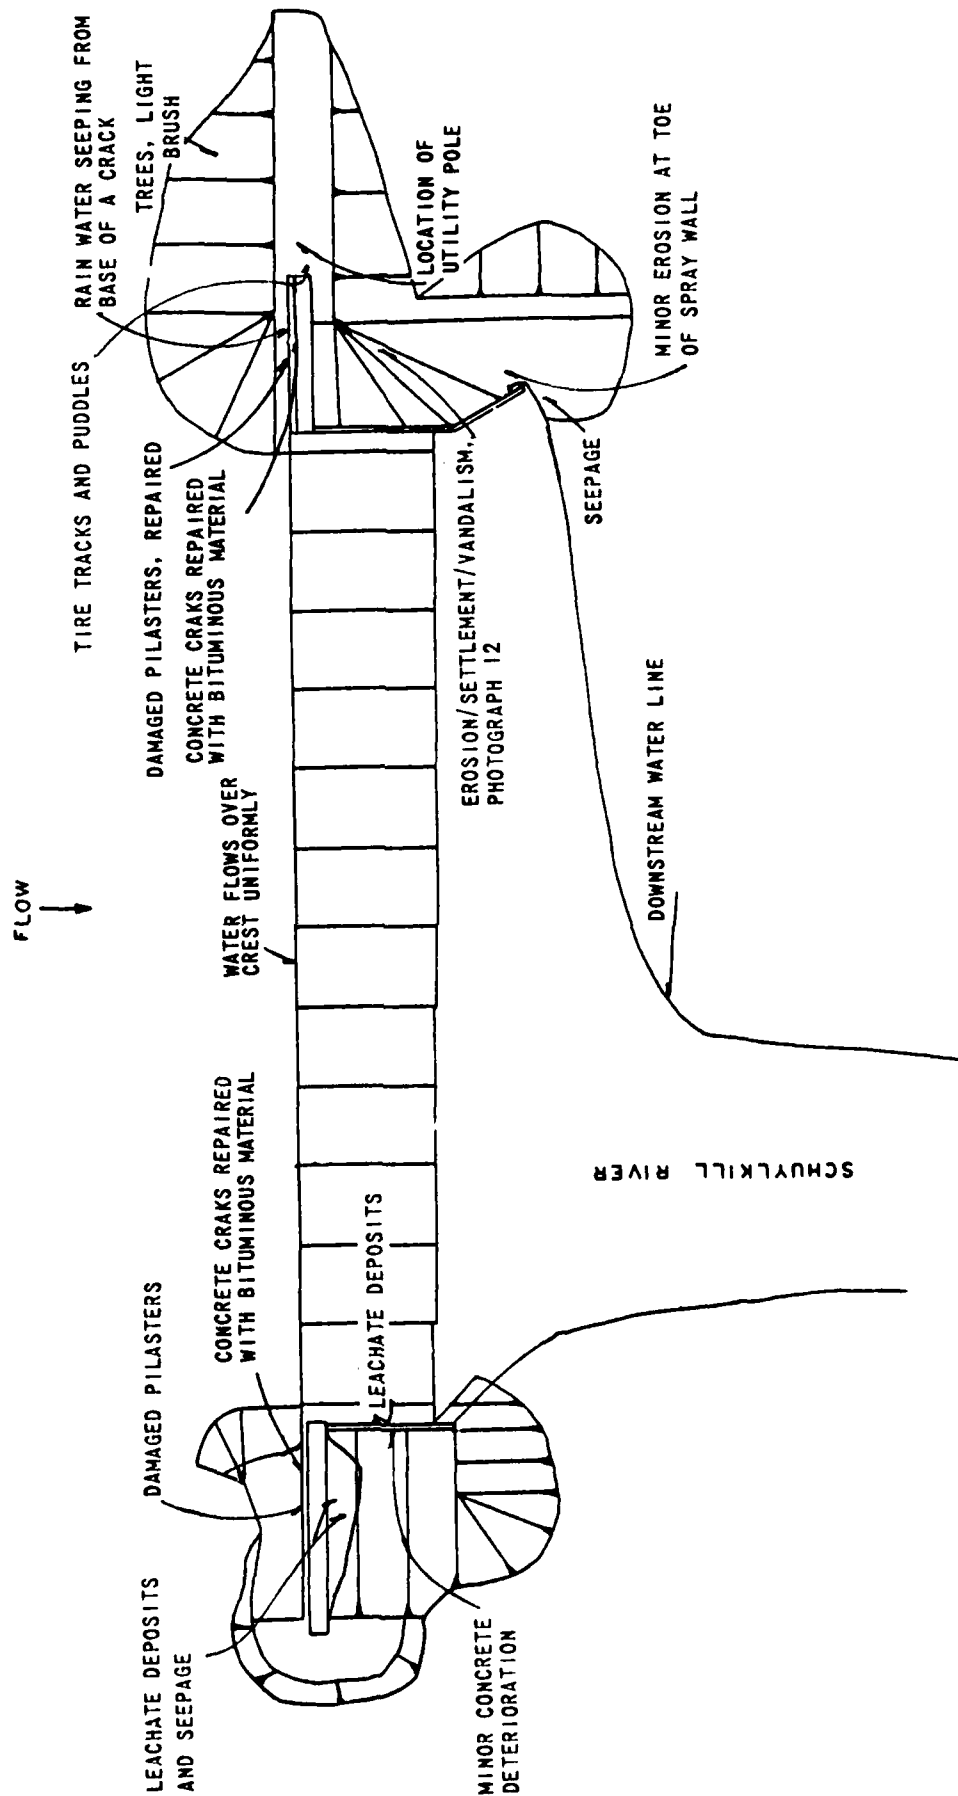
SHEET 5A OF 11

FIELD OBSERVATION PLAN
AUBURN DAM

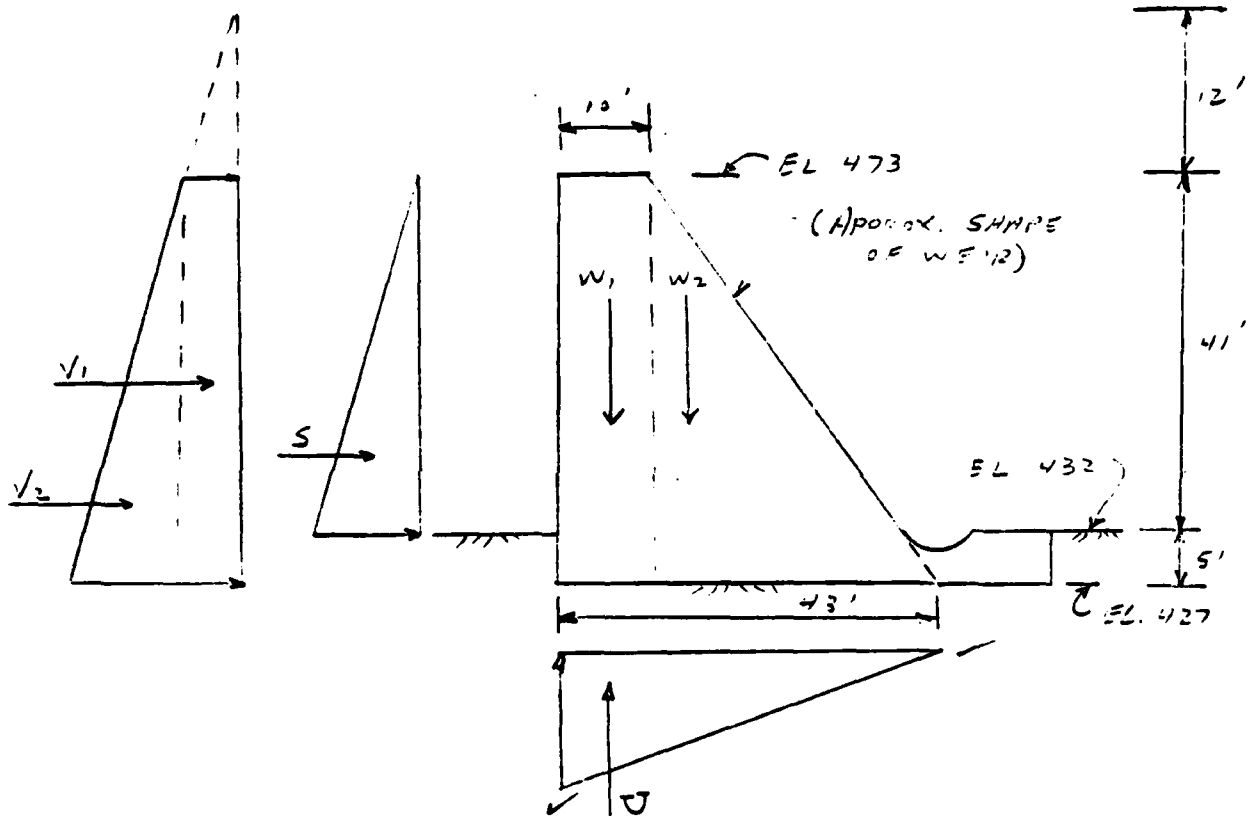
OVERFLOW SECTION:

$$\begin{aligned}
 W_1 &= (0.150)(10)(46) = 69.0 \text{ KIPS} \\
 W_2 &= \frac{1}{2}(0.150)(33)(46) = 113.8 \text{ KIPS} \\
 V_1 &= (12)(0.0624)(46) = 34.4 \text{ KIPS} \\
 V_2 &= \frac{1}{2}(0.0624)(46)^2 = 66.0 \text{ KIPS} \\
 S &= \frac{1}{2}(0.50)(0.040)(41)^2 = 16.8 \text{ KIPS} \\
 U &= \frac{1}{2}(0.0624)(50)(43) = 77.8 \text{ KIPS}
 \end{aligned}$$

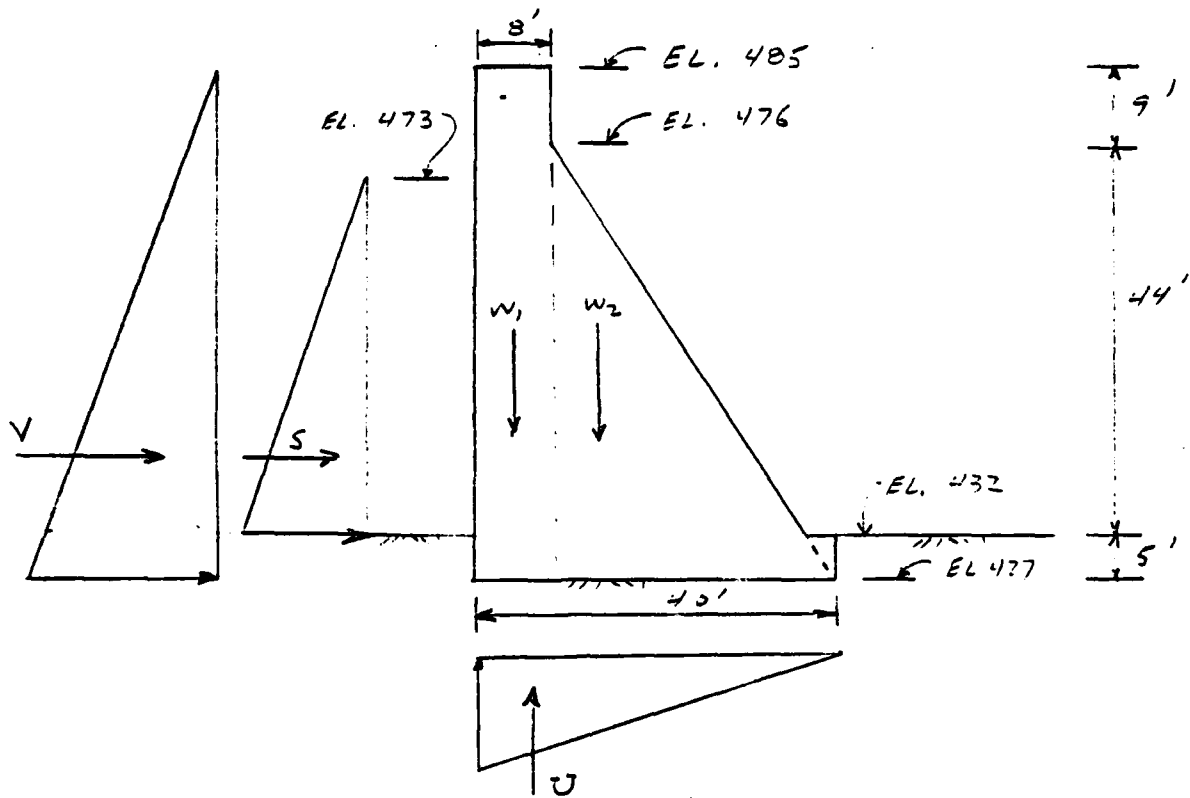
NON-OVERFLOW SECTION:

$$W_1 = (2.150)(8)(50) = 69.6 \text{ KIPS} \checkmark$$

$$W_2 = \frac{1}{2} (0.150)(49)(32) = 117.6 \text{ KIPS} \checkmark$$
